# Sample Report

Pool Barrier Compliance Report (Victoria)

Applicable barrier standard:	Part 9A - Division 2 of the Building Regulations 2018
------------------------------	---

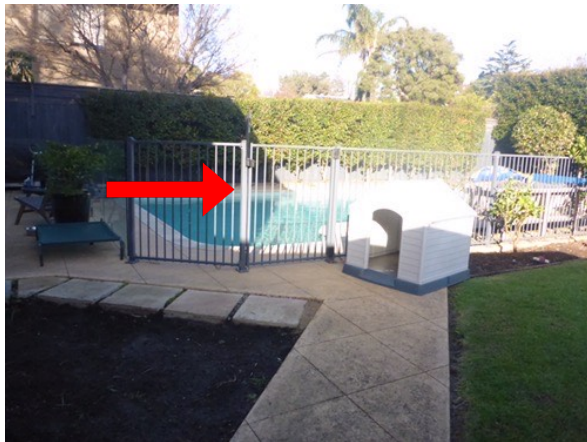
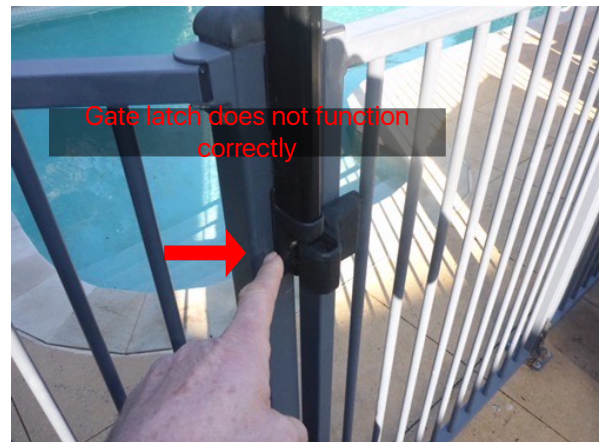
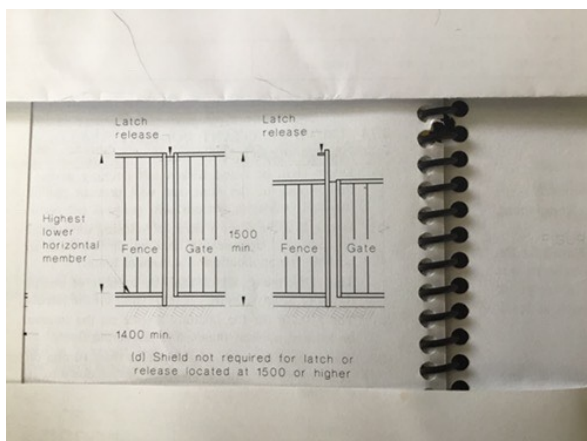
### Non compliant item 1.01

Location: Pool Enclosure

Finding: Barrier gate

The pool barrier gate does function correctly

Pool barrier gates must be self closing and self latching with the gate release mechanism located not less than 1500 mm above floor / ground level

The barrier gate must open away from the pool

Rectification required: The gate will need to be serviced and or rectified in order to comply

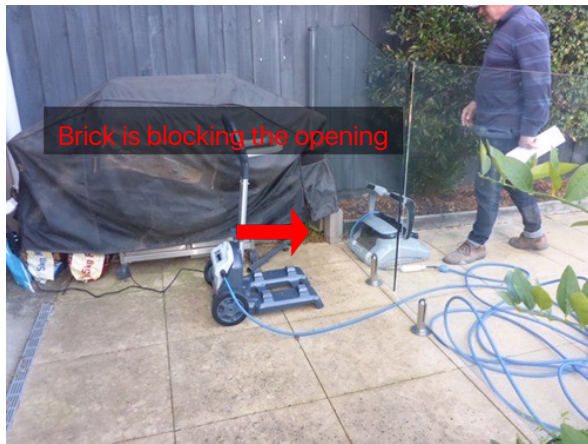
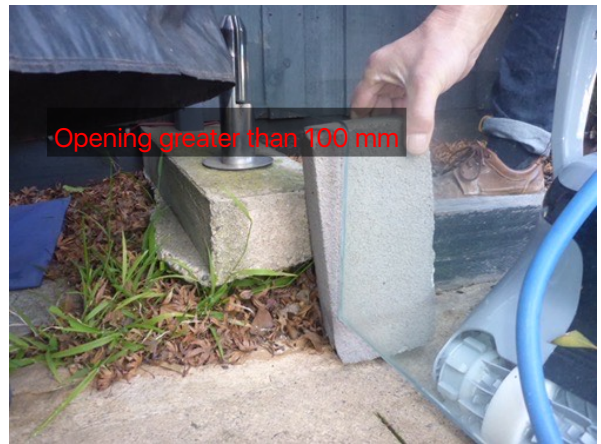
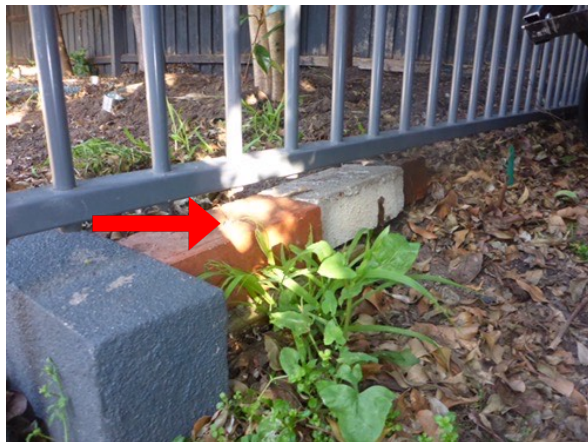
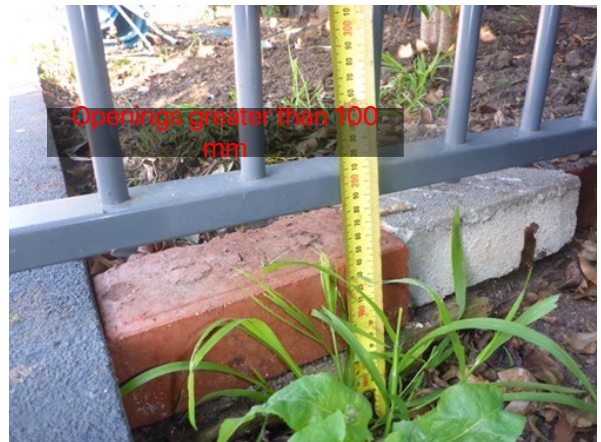
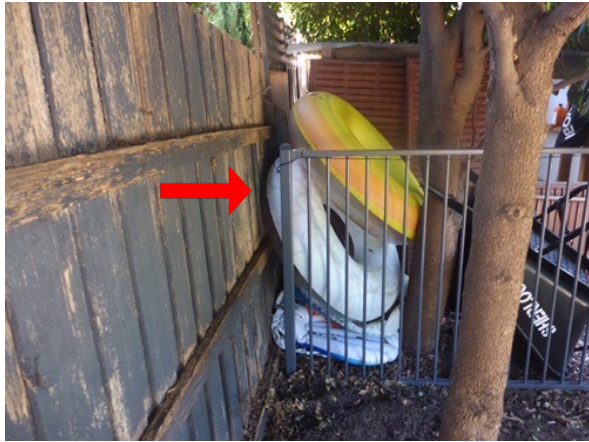
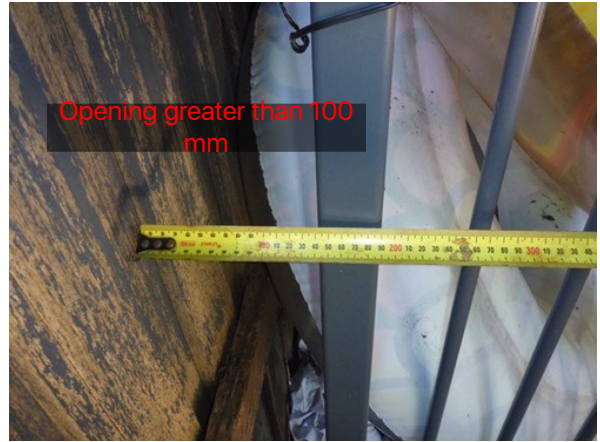
## Non compliant item 1.02

Ground Clearance

The size of any opening within, adjacent to or between the bottom of the fencing and the finished ground level shall not exceed 100 mm

Current standard 1926.1 2012 section 2.3.7

Goes on to say "the surface beneath the barrier shall be permanent and not easily removed or eroded by a young child, animals, or weather"

Rectification required: Openings around the pool need to be reduced or closed in order to comply

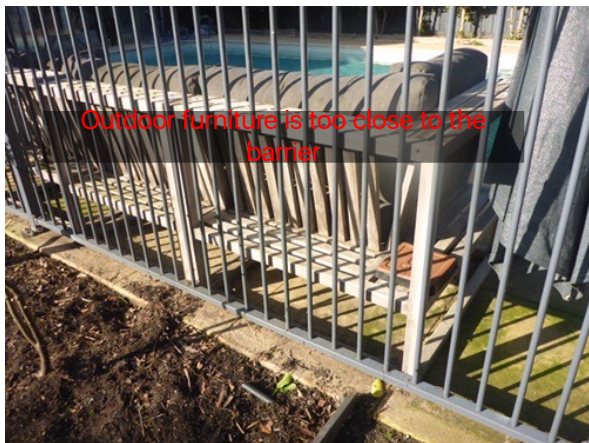
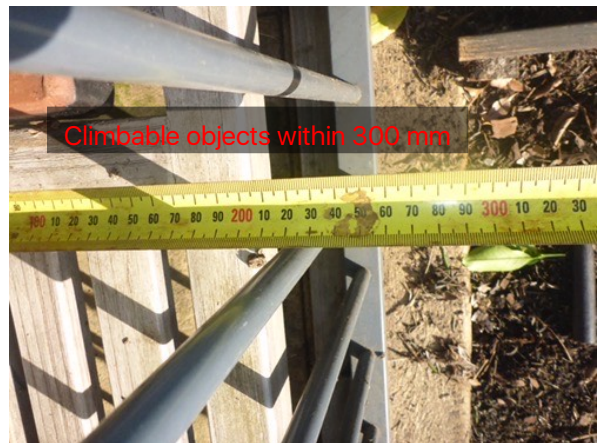
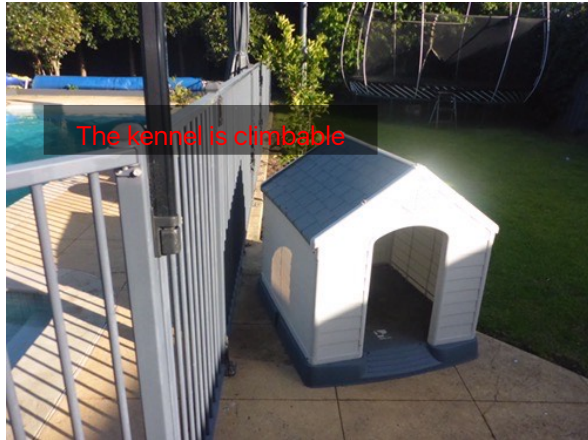
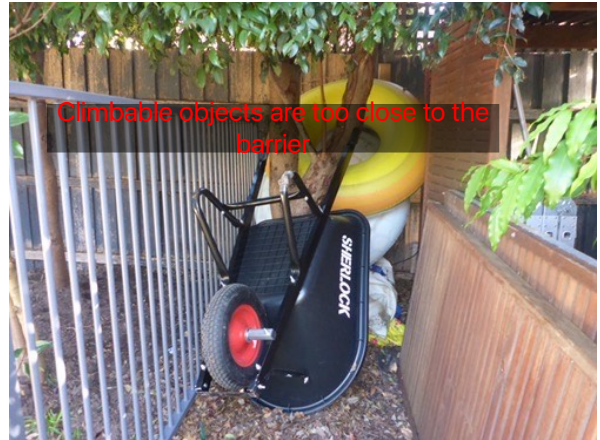
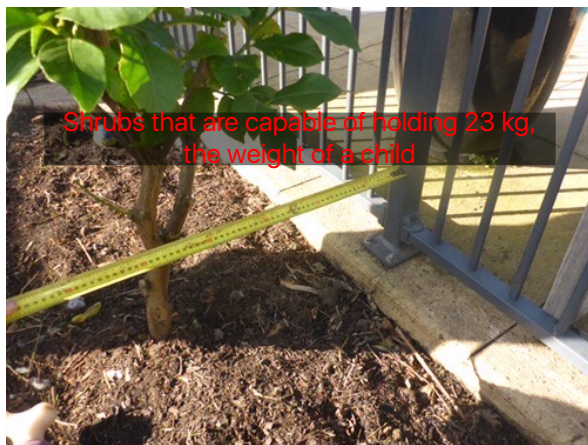
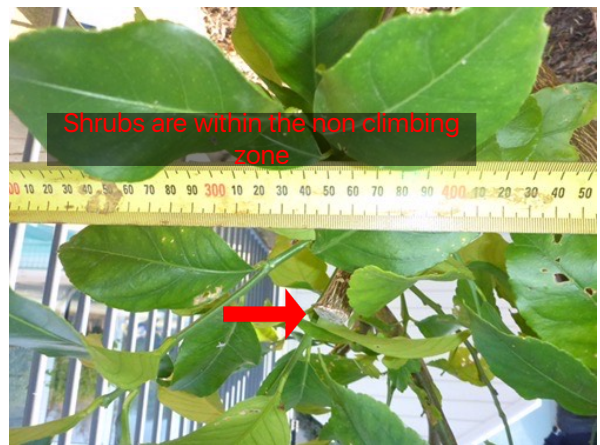
## Non compliant item 1.03

Location: Pool Enclosure

Finding: Footholds

There are numerous climbable objects within the 1200mm clear span measured from the top of the fence on the approach side, these would include trees, fence rails, planter boxes, bbq's, fixtures or wall ornaments or the like.

Planter boxes or any other object that could be used as a foothold are not permitted within 500 mm of the pool barrier on the outside or 300 mm of the pool barrier on the inside

Shrubs or branches capable of supporting 23 kg (deemed to be the weight of the child) are not permitted within 500 mm of the pool barrier

Rectification required: All objects that are within the 500mm of the outside of a pool barrier and 300mm on the inside of the pool barrier should be removed or protected to prevent them from being used as footholds

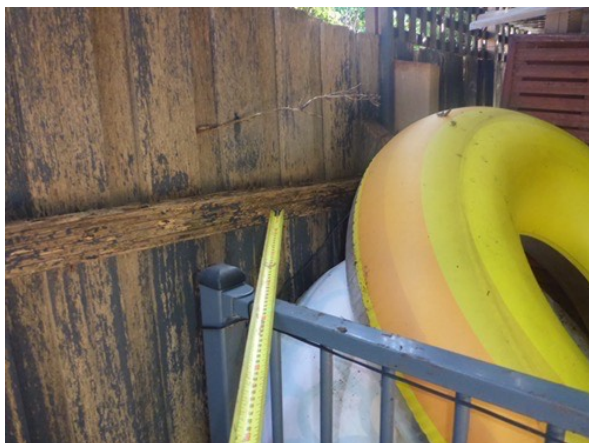
## Non compliant item 1.05

Pool enclosure

The fence rails present a foothold within 500 mm on the outside and 300 mm on the inside of the pool enclosure

Rectification required: The fence could be covered with a non climbable material or the rails made unclimbable

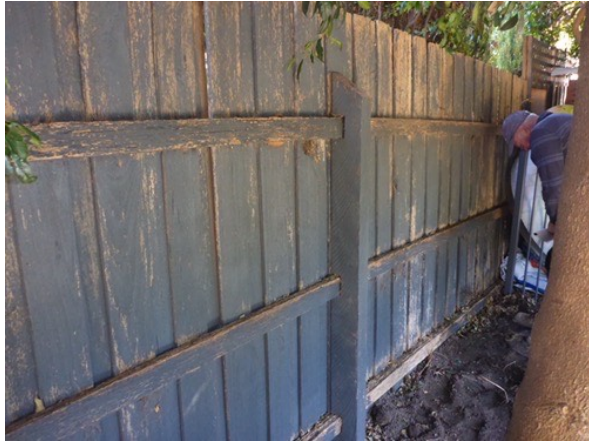
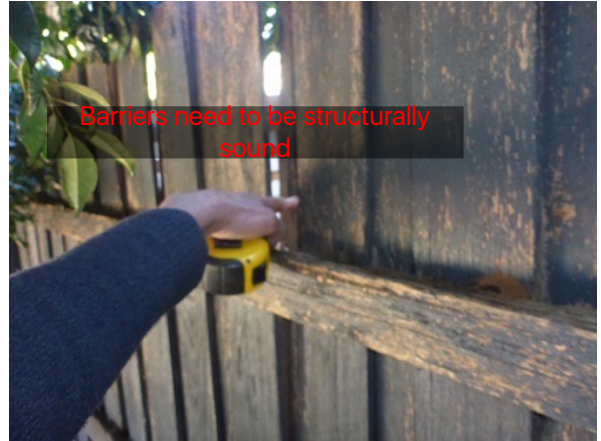
Location: Pool Enclosure

Finding: Boundary Paling fence  
Boundary fences forming part of a pool enclosure must be structurally sound.  
There are loose palings on the boundary fence

Rectification required: The palings should be replaced to ensure the structural integrity of the boundary fence

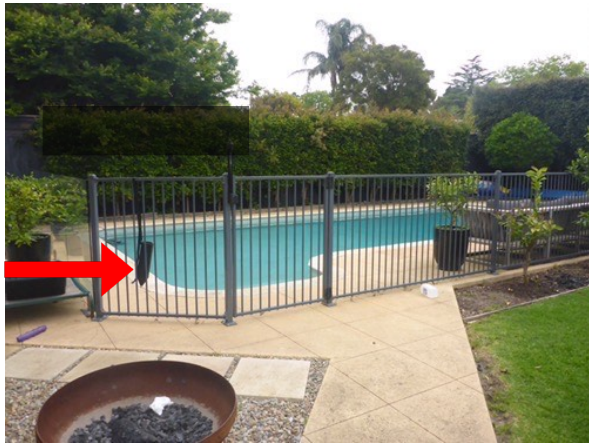
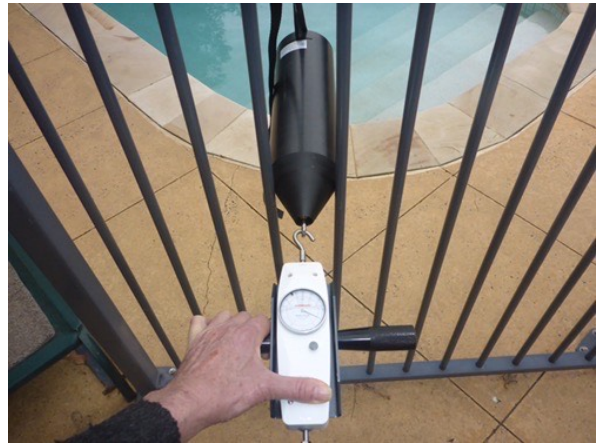
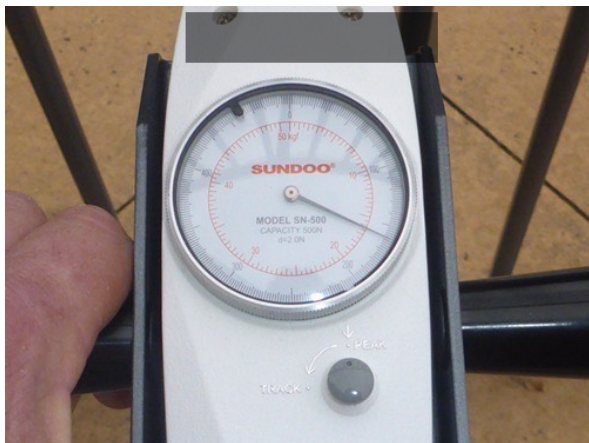
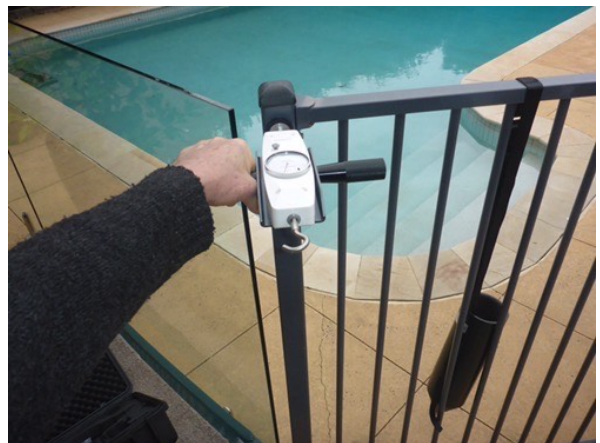
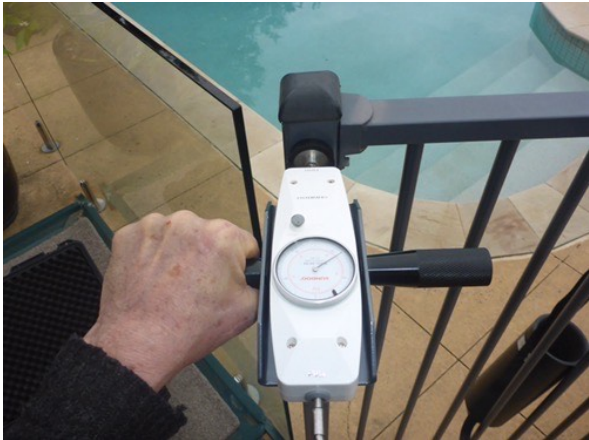
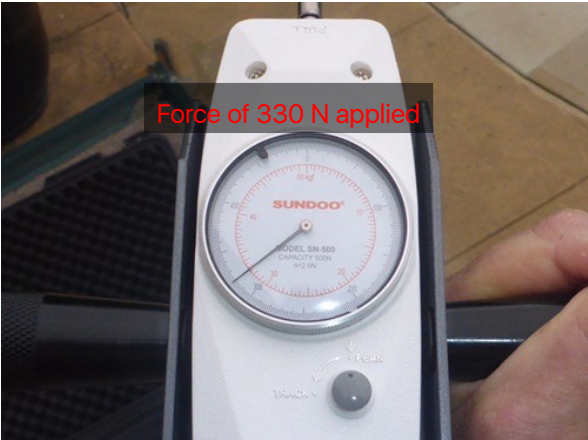
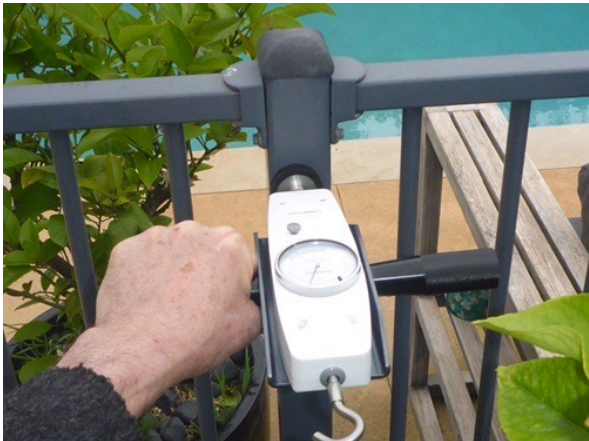
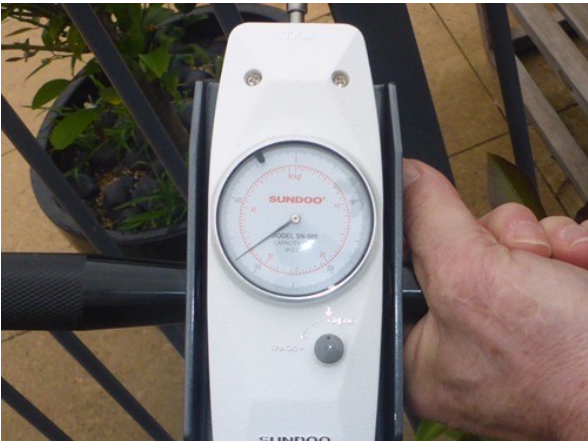
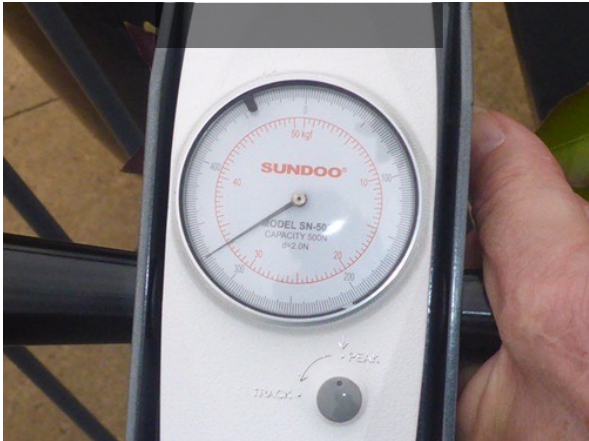
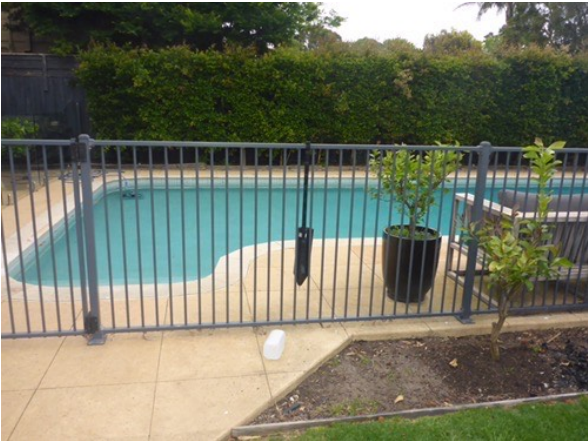
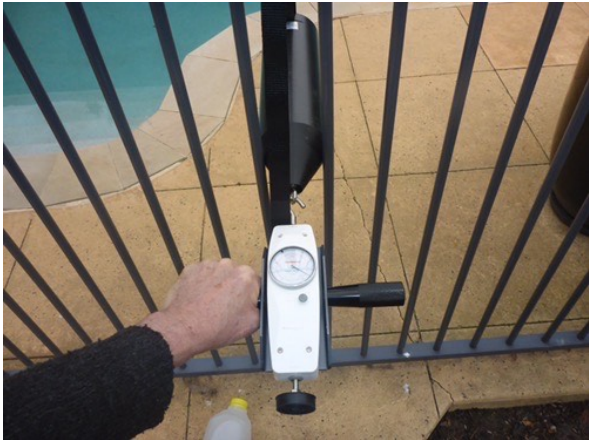
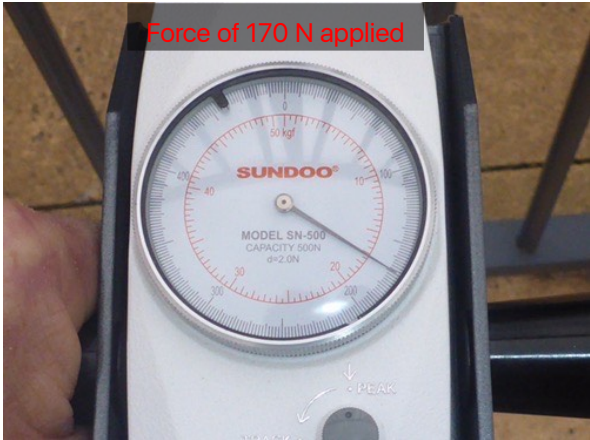
## Observation 2.06

Location: Barrier Fence

Finding: Rigidity test

The fence and the posts were tested using a Sundoo analog force gauge. The fence was tested three times per panel and each post.

These photographs are indicative of the results

A cylindrical object was placed mid span of the fence and a measurable force of not less than 150 N was applied. The cylindrical object did not pass through the rails.

The gauge was then used to apply a horizontal force of not less than 330 N to the posts at 1200mm above the ground. No deviation bending or movement of the ground fixing was observed

Rectification required: No rectification work required
